ENGINEERING ORDER

EO. No: A320HC52-004/14 R0

SUBJECT: ATA 52 - DOORS - LH NOSE LANDING GEAR DOOR - EROSION - PERMANENT REPAIR

SUMMARY: This EO is to repair an erosion on LH landing Gear Door.

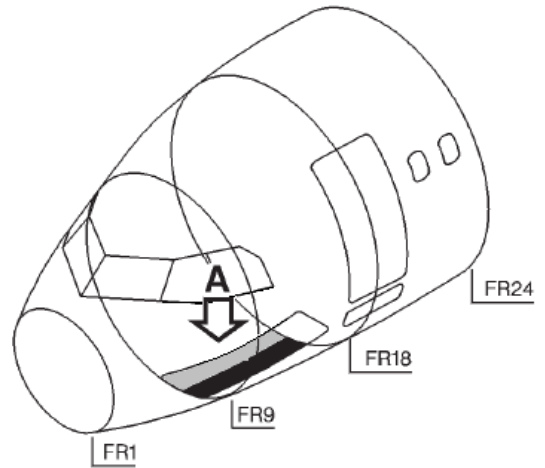
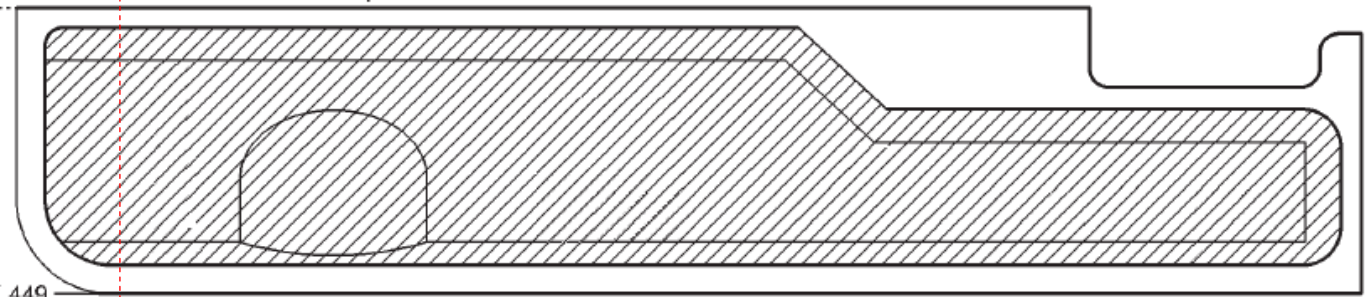
FIGURE 1 SHEET 1 OF 3

During major check at AEROMAN (SAL), LH and RH NLG doors of subject A/C were found with erosion damages on their fwd edges as shown in figure 1 of this report (Ref. /A/: AEM-14-04866/000). These damaged areas are out of repairable limits of A320 SRM 52-82-11.

IAW A320 SRM 52-82-11
FIG 1 ITEM 1B PANEL P/N:
D52810111002 (LH SIDE)
D52810111003 (RH SIDE)

REFER TO **DETAIL A** FOR
DAMAGED AREA LOCATION
AND DIMENSIONS ON LH
NLG DOOR PANEL.

REFER TO **DETAIL B** FOR
DAMAGED AREA LOCATION
AND DIMENSIONS ON RH
NLG DOOR PANEL.

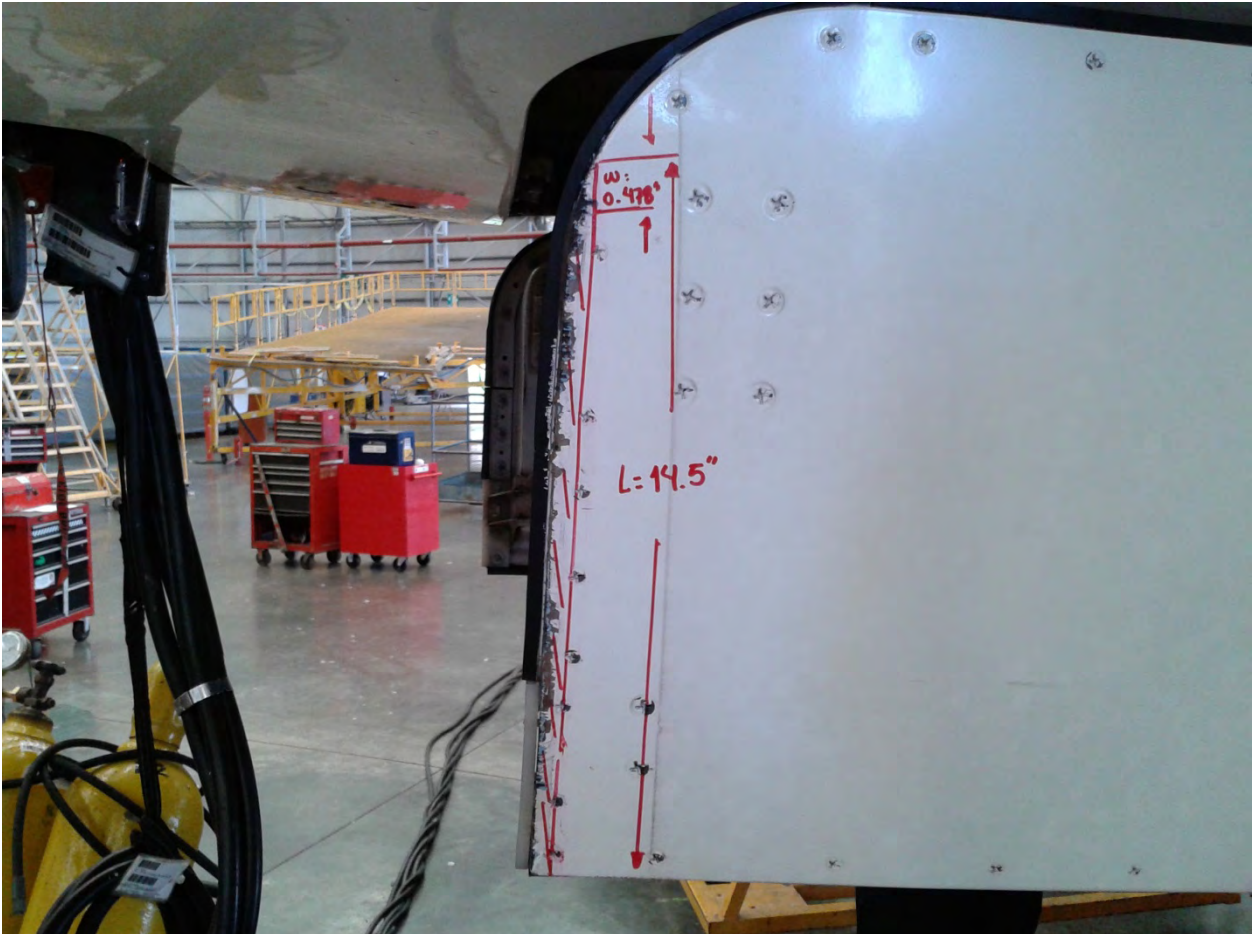
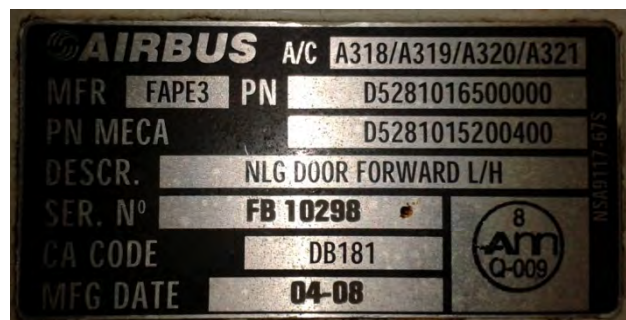
**DETAIL A. ERODED AREA
LOCATION AND DIMENSIONS
ON LH NLG DOOR PANEL.**

ERODED AREA:

Length = 14.5 inch.

Width = 0.478 inch.

Depth = 4 Plies.

No Skydrol Contamination

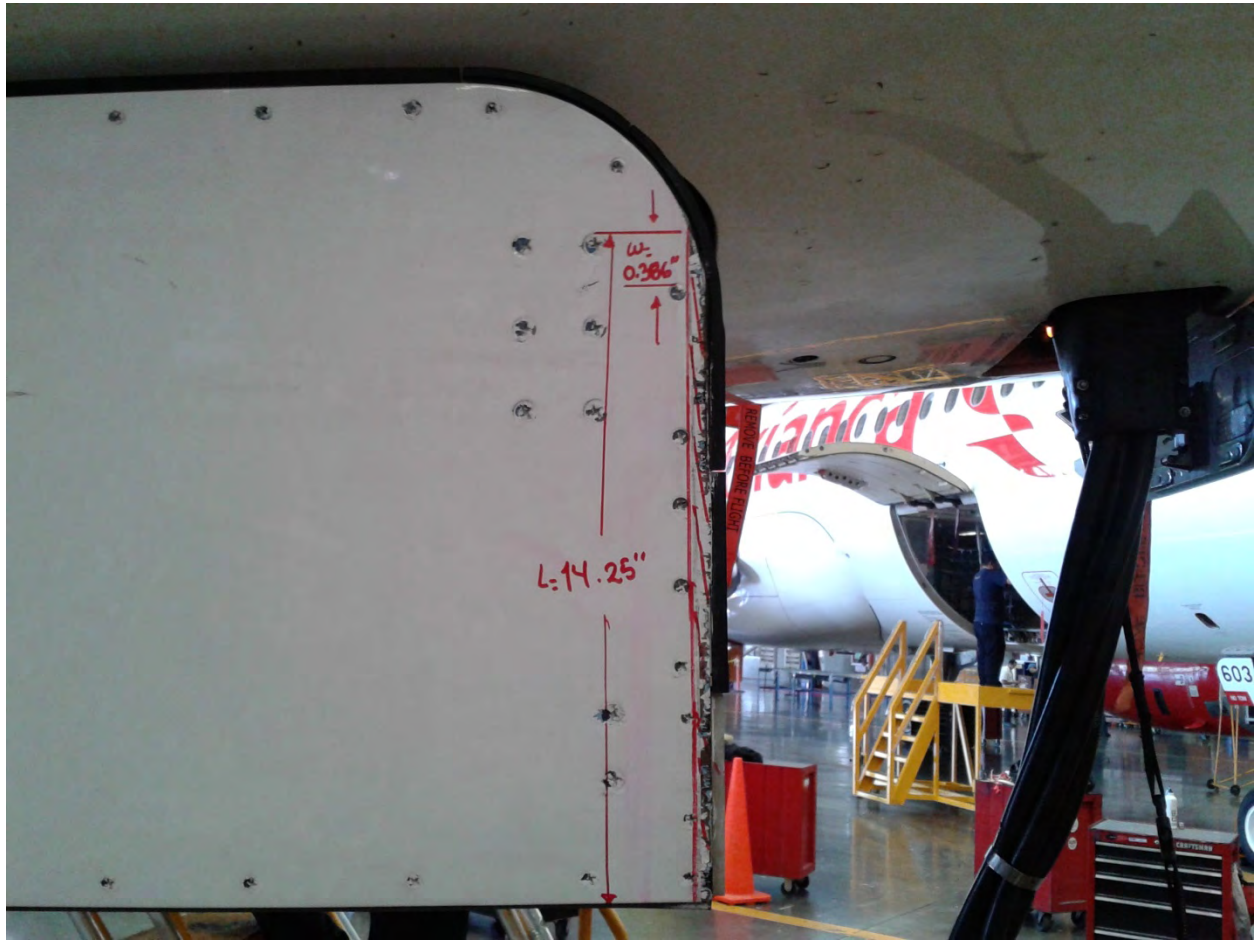
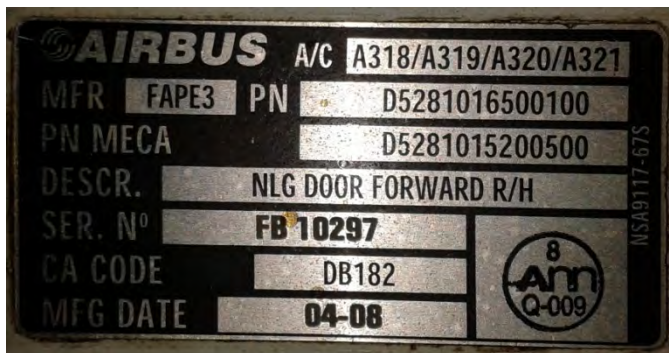
**DETAIL B. ERODED AREA
LOCATION AND DIMENSIONS
ON RH NLG DOOR PANEL.**

ERODED AREA:

Length = 14.25 inch.

Width = 0.386 inch.

Depth = 4 Plies.

No Skydrol Contamination

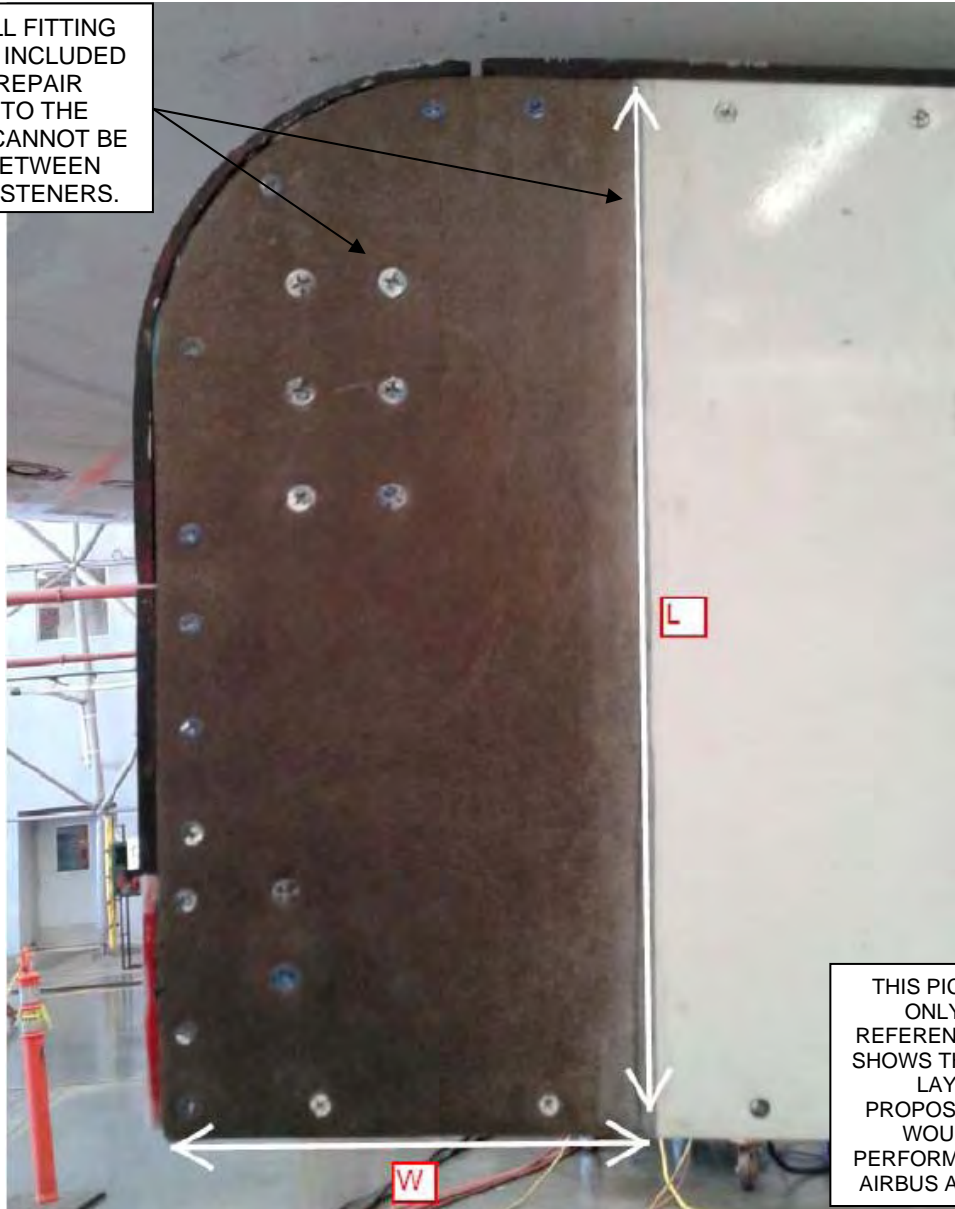
FIGURE 2 SHEET 1 OF 1

**FINAL REPAIR LAYOUT PROPOSED
FOR LH AND RH NLG DOOR PANELS.**

NOTICE THAT ALL FITTING FASTENERS ARE INCLUDED WITHIN THIS REPAIR LAYOUT, DUE TO THE SPLICING PLIES CANNOT BE PERFORMED BETWEEN FITTING ROW FASTENERS.

- b) Include all fitting fasteners within the repair due to the splicing plies cannot be performed between fitting row fasteners. Figure 2 of this report (Ref. /A/: AEM-14-04866/000) shows repair layout proposed to be accomplished as above described.

THIS PICTURE IS ONLY FOR REFERENCE AND IT SHOWS THE REPAIR LAYOUT PROPOSED, THAT WOULD BE PERFORMED AFTER AIRBUS APPROVAL

LENGTH AND WIDTH OF REPAIRED AREA TO BE PROVIDED ON RDAS REQUEST MESSAGE, WHEN REPAIR IS TO BE ACCOMPLISHED.
